TECHNICAL REPORT NO. 184-1

**Spillway Tailwater Channel Erosion at  
Little Goose Dam  
Snake River, Washington**

**SPONSORED BY  
U. S. ARMY CORPS OF ENGINEERS  
WALLA WALLA**

**December, 1983**

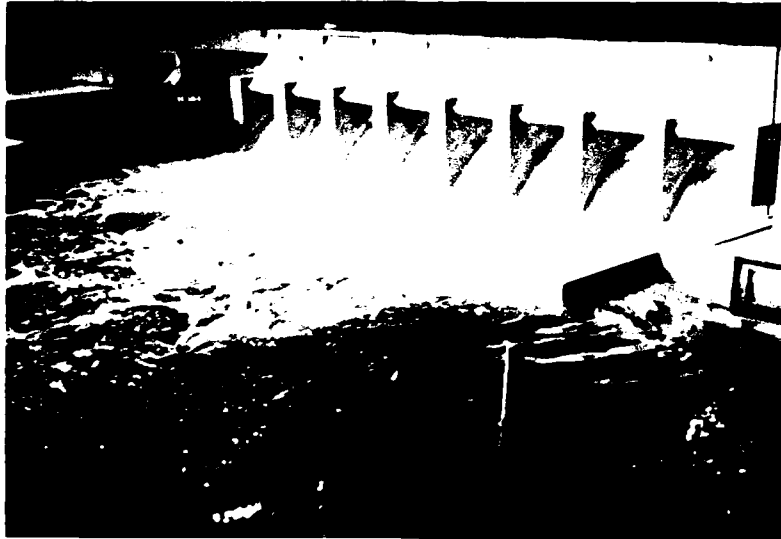
Photograph 5

Surface flow conditions at spillway  
 River discharge 120,000 cfs, tailwater elev. 541.2  
 Spillway discharge 55,500 cfs, pool elev. 638  
 Powerhouse units 1 to 3, discharge 64,500 cfs

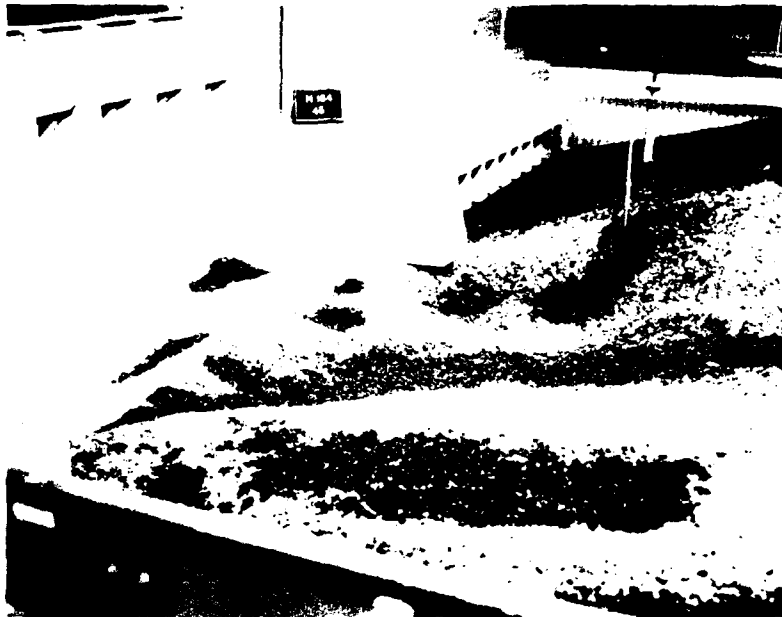
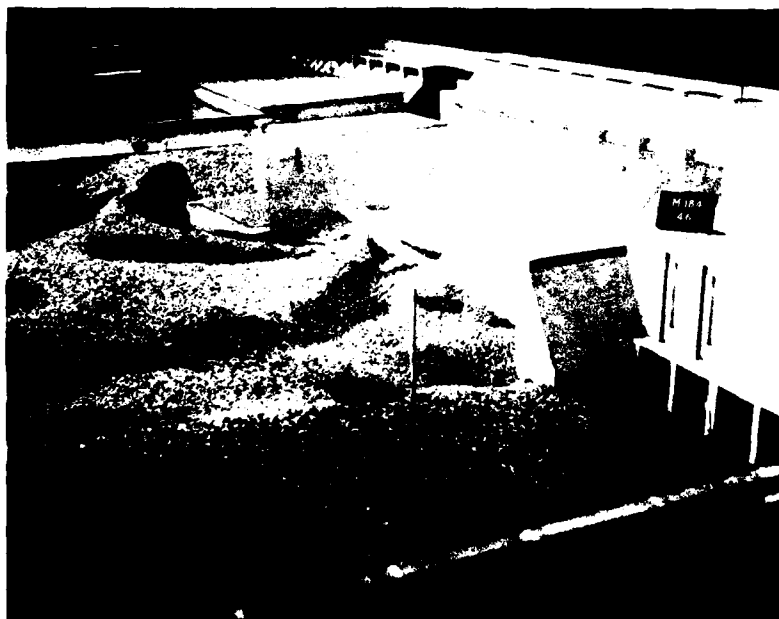
Photograph 21

Channel topography after river discharge 250,000 cfs  
with spillway discharge 184,000 cfs

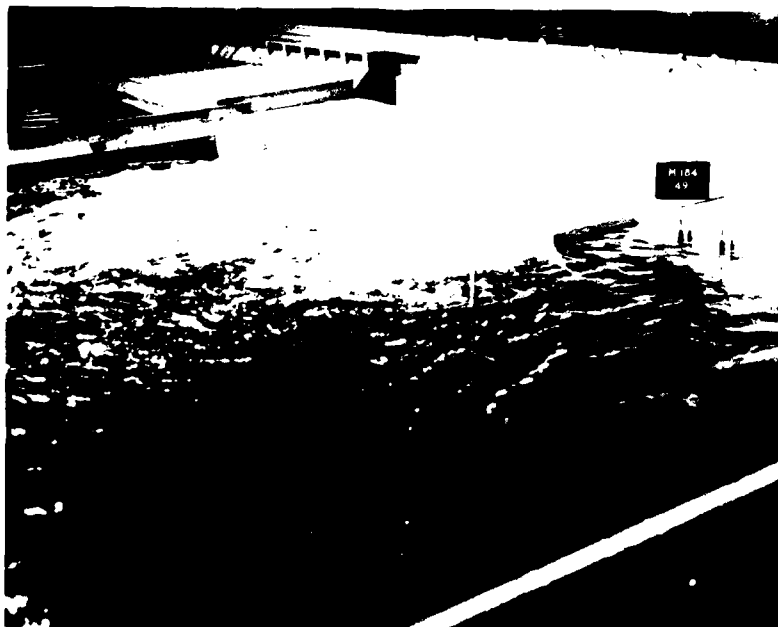
Photograph 23

Flow conditions same as with 250,000 cfs. Additional erosion downstream from bay 7. Additional deposition against bucket at bay 6. No additional erosion at the walls. Rock carried into bucket in bays 4 to 6 and agitated until moved to end bays and washed out of the bucket. Only small amount of rock remained in bucket at end of test.

Surface flow conditions at spillway  
 River discharge 280,000 cfs, tailwater elev. 544.7  
 Spillway discharge 214,000 cfs, pool elev. 638  
 Powerhouse units 1 to 3, discharge 66,000 cfs

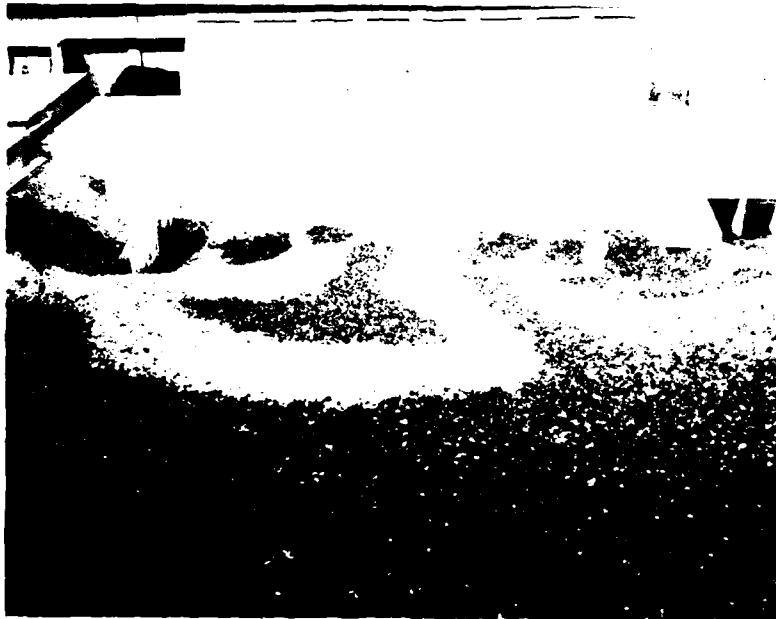
Photograph 31

Channel topography after river discharge 300,000 cfs  
with spillway discharge 234,000 cfs

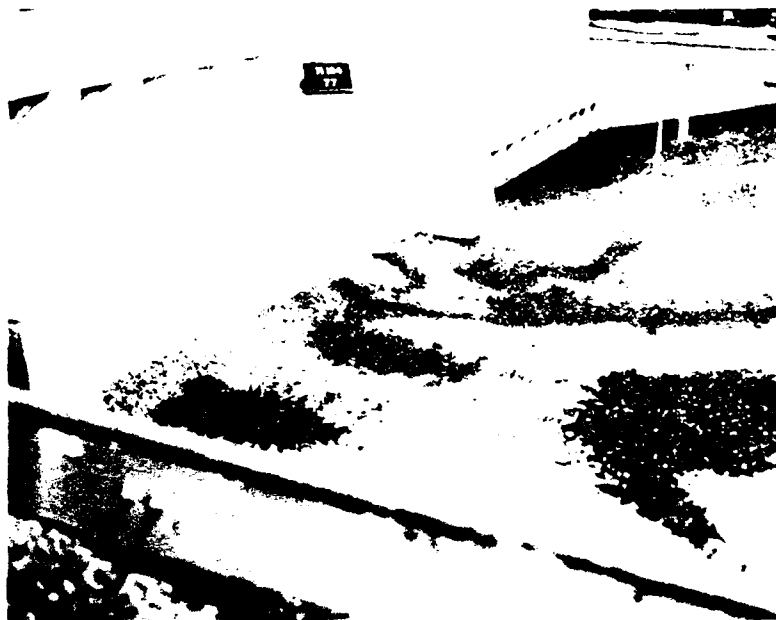
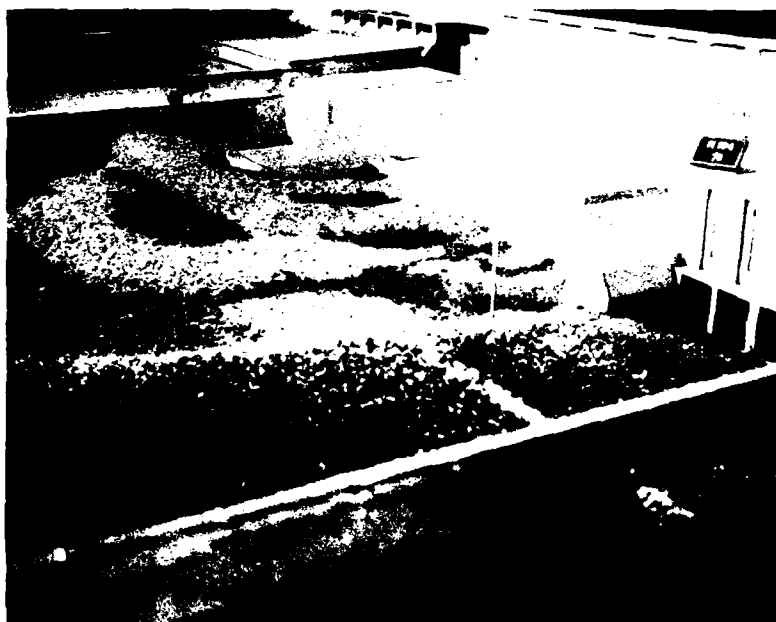
Photograph 41

Channel topography after river discharge 350,000 cfs  
with spillway discharge 284,000 cfs

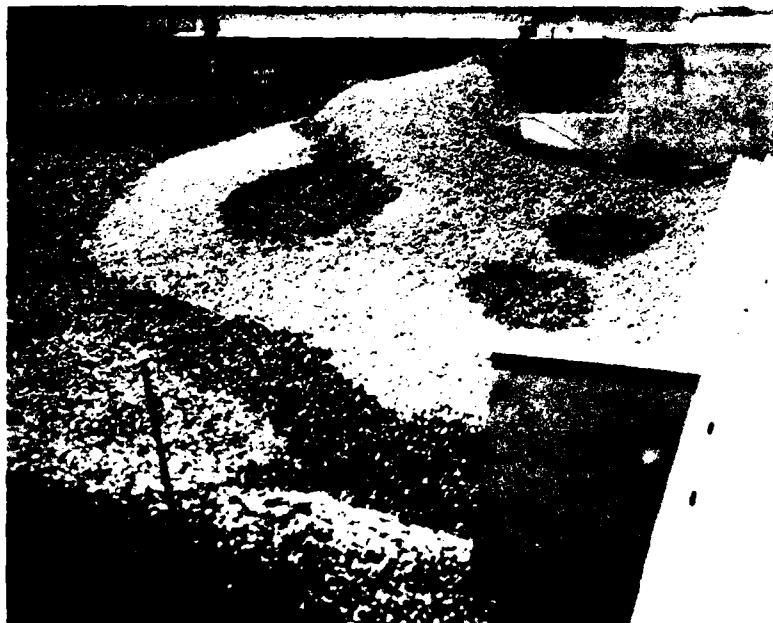
Photograph 49

Channel topography after river discharge 400,000 cfs  
with spillway discharge 334,000 cfs

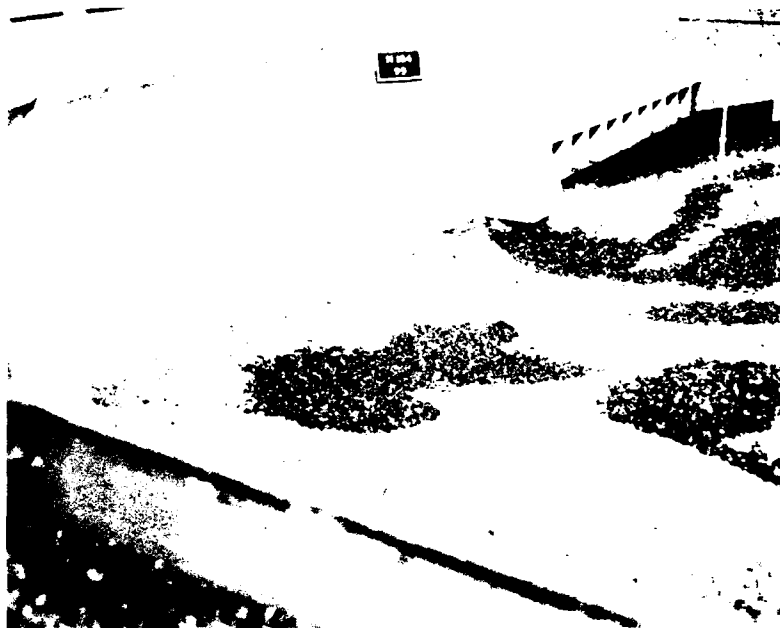
Photograph 55

Channel topography after river discharge 420,000 cfs  
with spillway discharge 354,000 cfs

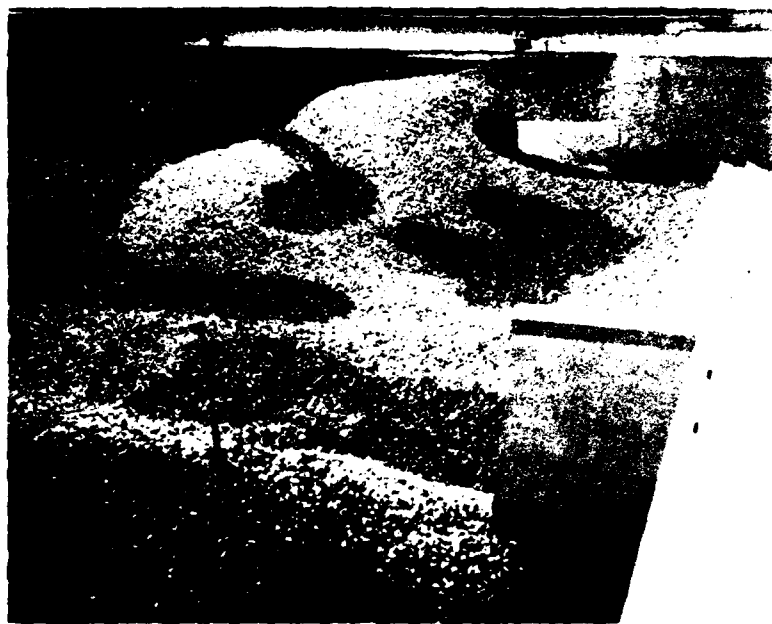
Photograph 57

Channel topography after river discharge 420,000 cfs  
with spillway discharge 354,000 cfs

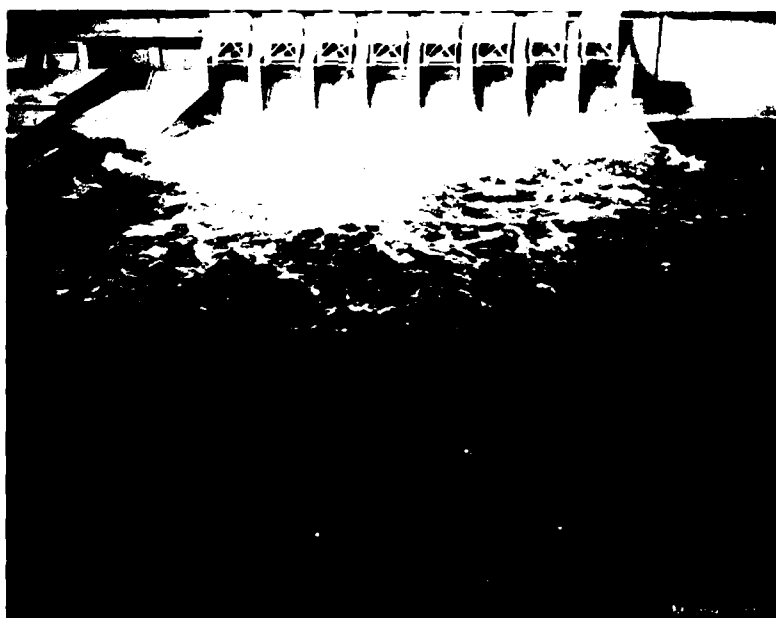
Photograph 67

Surface flow conditions at spillway  
River discharge 530,000 cfs, tailwater elev. 551.0  
Spillway flow only, pool elev. 638

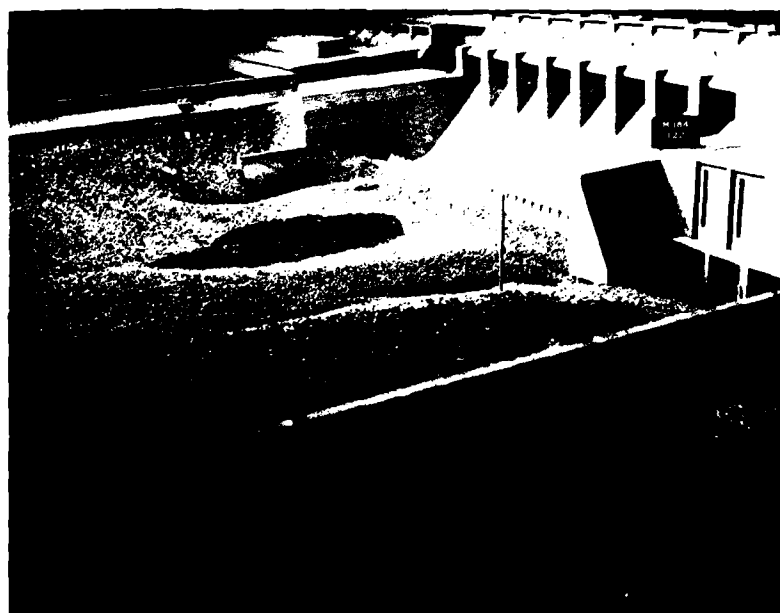
Photograph 72

Channel topography after river discharge 5300,000 cfs  
with spillway flow only
